Doc. No.: HS-195ENG	<h1 style="margin: 0;">IRATA</h1> <h2 style="margin: 0;">Safety Bulletin No. 44</h2>	 
Date of Issue: 21/11/17		
Issue No.: 002		
Page 1 of 6

SAFETY BULLETIN NO. 44: ROPE ACCESS MAIN ROPE FAILURE

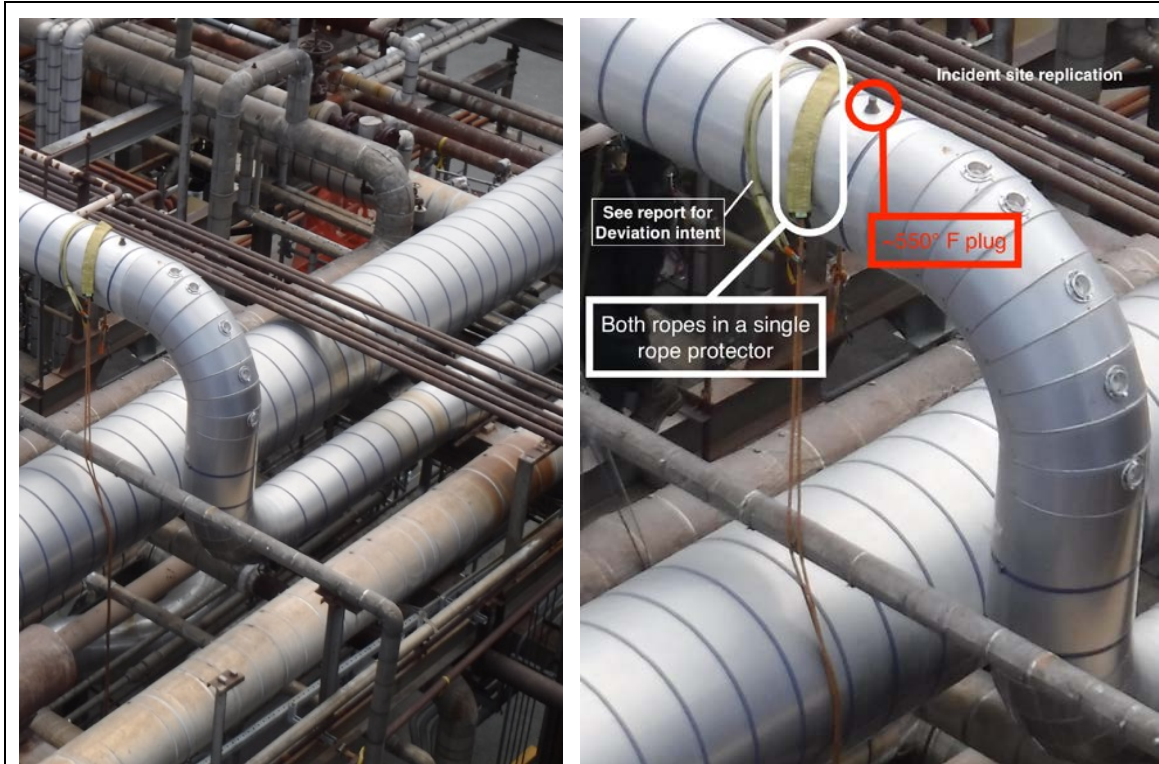
3.2.1 A rope system was rigged by a Level 3 rope access technician over an insulated pipe, to establish a high-point deviation (sometimes known as an "up and over" directional). See **Figure 1**. Both the main rope and the safety rope were placed in a single, fabric rope protection sleeve to guard against rough and uneven surface hazards.

3.2.2 The technician ascended the ropes from ground-level. When the main rope was loaded, the system moved laterally such that it made contact with an exposed metal plug located on top of the insulated pipe.

NOTE: The surface temperature of the 1" diameter metal plug was found later to be approximately 550 degrees Fahrenheit (288 degrees Celsius).

Figure 1: Recreation of the incident scene

- (ii) The deviation (see **Figure 1**, right) was intended to guard against a different hazard (viz. rope travel over the large pipe's elbow) and, therefore, did not engage the rope system early enough to prevent contact with the hot metal plug.

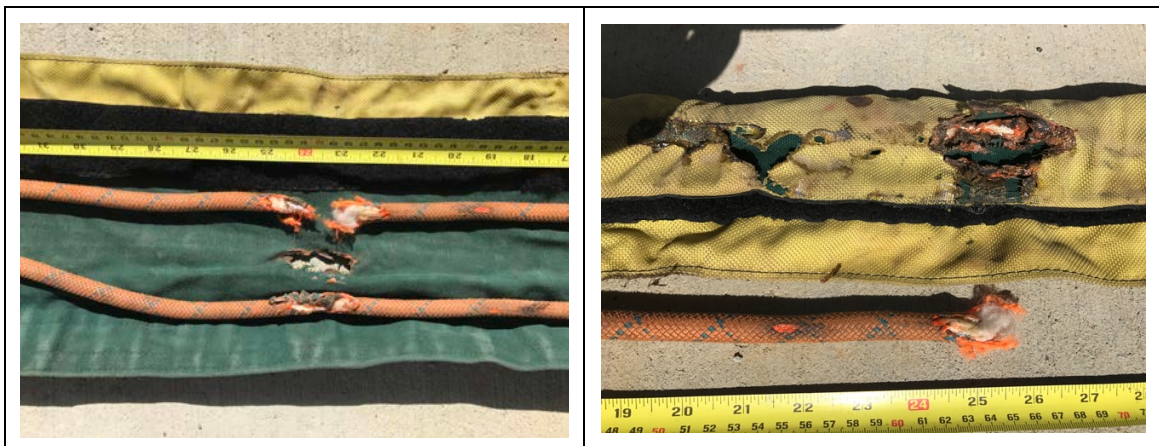
3.2.3 Once the technician reached approximately 6 metres in elevation, the hot plug melted through both the rope protector (nylon/canvas) and the main rope to the point of failure. The technician fell approximately 1 metre until arrested by their back-up safety system. The technician immediately transferred body weight to the adjacent structure and, secured in position with an additional anchorage, waited until a new set of ropes were lowered into position.

3.2.5 An inspection of the damaged equipment involved showed that the main rope had melted through and the back-up safety rope had melted half through (approximately). See **Figure 2**.

Figure 2: Damaged ropes and rope protector
